UNSTABLE PLATFORM

Trampoline injury requires
creative problem solving
to avoid iatrogenic injury

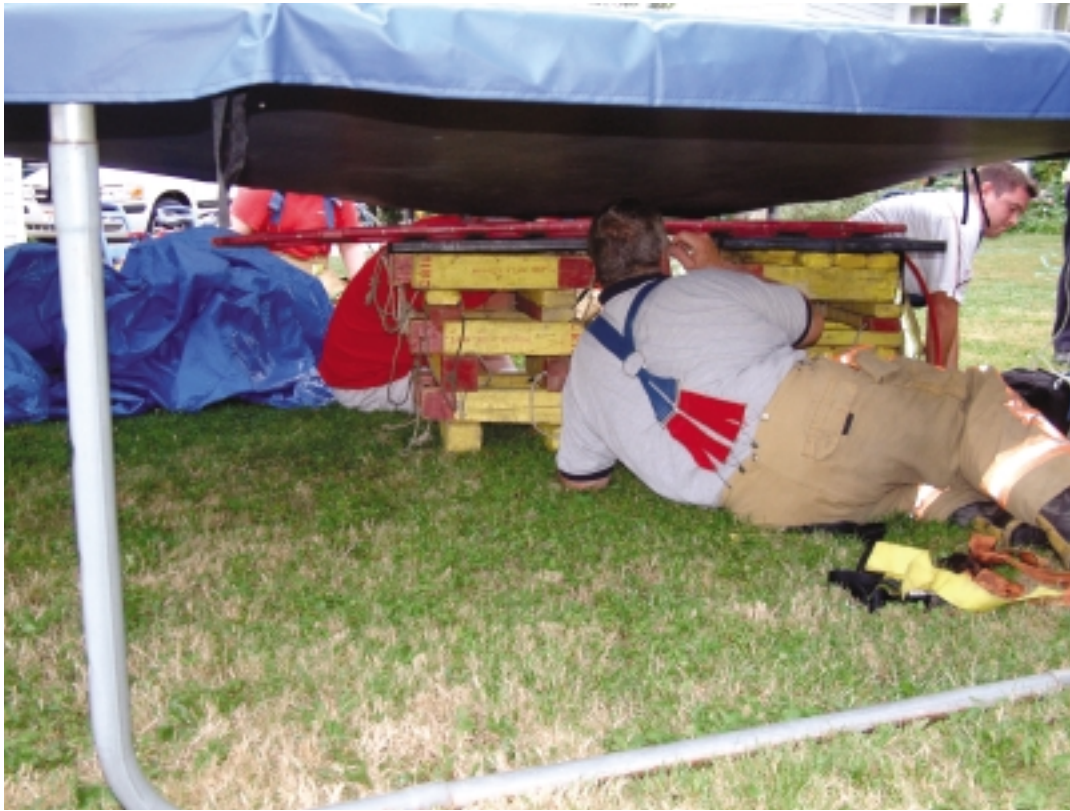
Photo 1: Responding to a backyard trampoline injury, crews work together as a team and use innovative methods to stabilize and prevent further injury to the patient.

On scene, Hudson EMS found a large, backyard trampoline, elevated three feet off the ground. The patient, an adult male, was lying on it, partially prone. His head was positioned near the edge of the canvas, and his feet were near the center (see [Photo 1](#), left). He was able to open his eyes and respond appropriately to questioning. He complained of some soreness in his neck. He denied any headache, change in vision, chest pain, shortness of breath, or abdominal, back or extremity pain. He also denied any numbness or tingling in his extremities. He stated that he had attempted to do a flip and had been unable to move since landing.

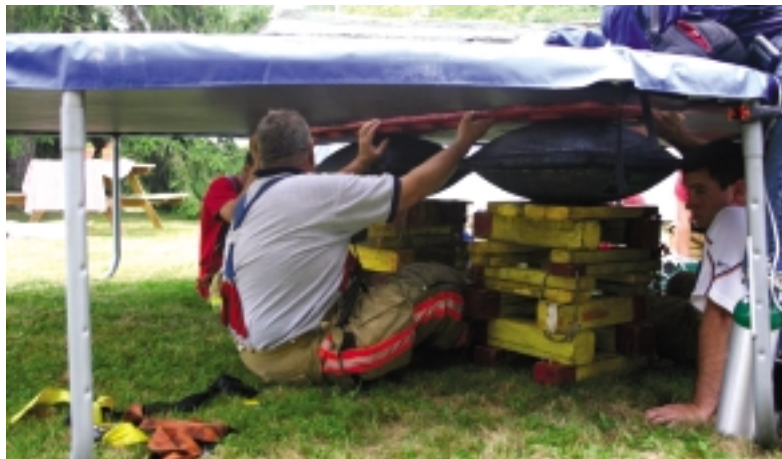
Photo 2: Two cribbing towers, air bags and a backboard are placed beneath the markedly sagging trampoline canvas to elevate and stabilize the patient prior to further immobilization.

The EMS incident commander requested the Hudson Fire Department for assistance with patient extrication. The EMS and fire incident commanders, brainstorming and soliciting input from others on scene, evaluated several options and elected to construct an "elevator" (see Photos 2 and 3, above) to level and stabilize the trampoline and patient. The amount of lifting necessary to bring

Two cribbing towers were placed beneath the patient. An inflatable air bag was placed on each tower, and a backboard was placed across the top of the air bags. With one crew stabilizing the patient from above and another crew stabilizing the elevator from below, the bags were slowly inflated.

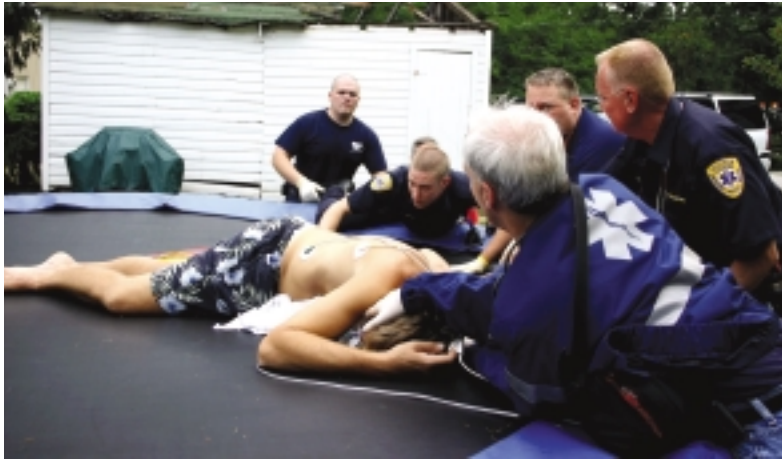
Photo 3: Post air-bag inflation, the patient is elevated to a non-sagging, horizontal position with the canvas stabilized to minimize motion.

the patient to a level position is evident in the pre- and post-inflation photos.

The backboard beneath the trampoline canvas rose gently, lifting the patient's body up to a level, horizontal position. It formed a rigid platform beneath the patient and helped stabilize the neighboring region of canvas. The pa-

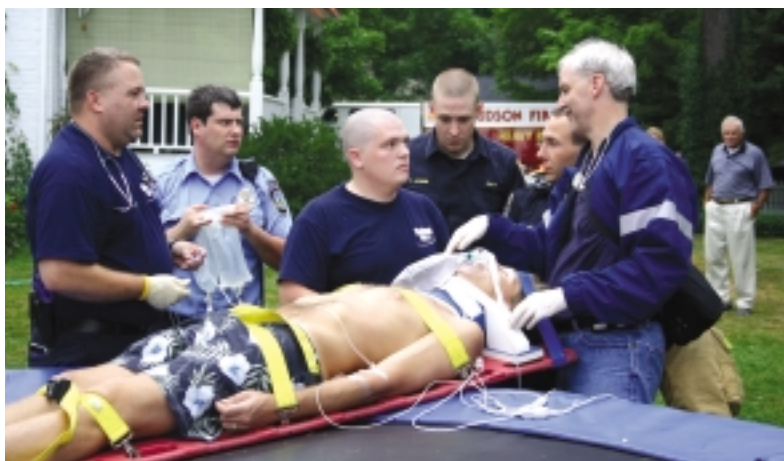
Photo 5: Neurovascular integrity is ascertained both prior to and following immobilization. Oxygen, fluids, monitoring and medications are instituted as warranted.

After the patient was positioned on the board, a cervical collar was carefully applied, followed by head blocks. The patient's neurologic status was assessed both pre- and post-positioning. Fortunately, there was no deterioration in the patient's baseline condition, no sudden apnea and no sudden death. Unfortunately, there was no readily apparent improvement in the patient's quadriplegia. (Photo 5 [p. 88] illustrates the patient post-immobilization and ready for transport.)
